1. Introduction

USA Environment has been retained by Clean Harbors to perform a radiological screening survey of the Wichita, KS facility in order to confirm and supplement data presented in the Kansas Department of Health and Environment report from a 2010 survey of the same property.¹ The site is located at 2549 North New York Avenue in the north-central portion of Wichita, Kansas. The site is approximately 6 acres and includes open field areas, paved/asphalted areas as well as several structures. Adjacent properties include the Missouri Pacific Railroad (MoPac RR) and the Union Pacific Railroad (UPRR) facilities to the north and west, and the former El Paso Corporation refinery to the south (previously decommissioned and demolished by USA Environment LP). The site is additionally bordered by New York Avenue, East Fork of Chisholm Creek, Hwy I-135 and a residential area are to the east.

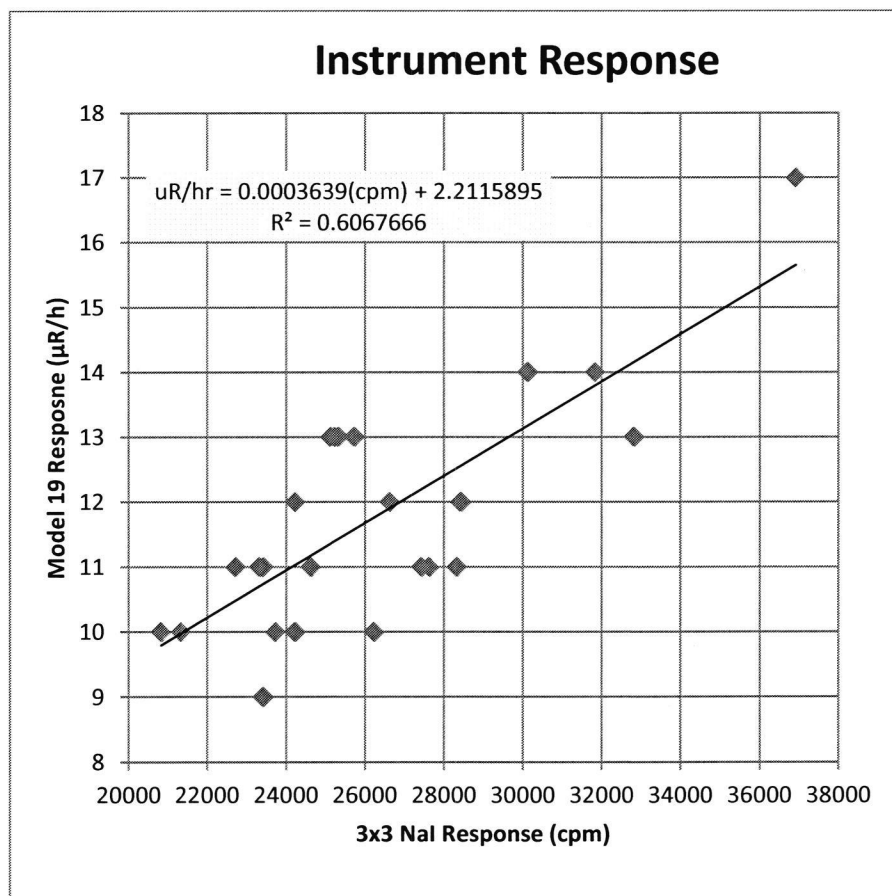
Figure 2. NaI detector response correlated to the Model 19 Response in order to determine $\mu\text{R/hr}$ gamma exposure measurements from cpm data.

Since all the detectors were calibrated to cesium-137 efficiency sources, a direct reading of $\mu\text{R/hr}$ cannot be determined due to the variance in energy response of NaI to gamma radiation. Instead, direct measurements were made in units of counts per minute. A Ludlum model 19 survey meter, which has a uniform energy response across the energies associated with radium-226 and efficiency sources was then used to conduct gamma exposure rate surveys at the sampling locations. The readings in $\mu\text{R/hr}$ were then correlated to the direct cpm measurements taken at the identical locations using the Ludlum 4421-3 survey meter with the 3"x3" NaI detector. A table containing the specific measurements made using each detector for each of the sampling locations is contained in Appendix III. Figure 2 below graphically displays this data and the correlation for converting cpm measurements to $\mu\text{R/hr}$.

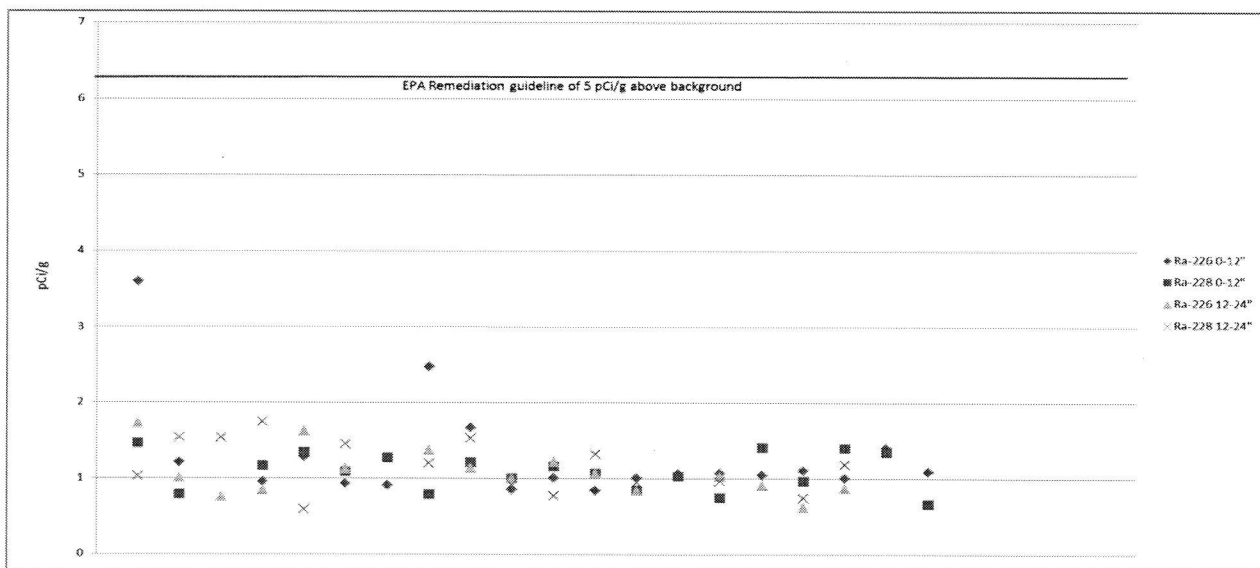
Figure 4. Graphical representation of sampling data relative to EPA guidelines.

Figure 4 shows the soil sampling data in comparison to EPA guidelines for allowable soil concentrations of radium-226. Table 2 lists the analytical data obtained from the soil samples collected. Sample results ranged from 0.62 to 3.60 pCi/g of radium -226. According to KDHE literature, typical background concentrations of radium-226 for this region ranges from 1-4 pCi/g.² Based on the median soil sample results, background concentrations of radium-226 were 1.1 pCi/g. Only two locations resulted in radium-226 concentrations statistically significant from background. The two were 2.5 and 3.6 pCi/g and occurred in the section that had previously contained the drain.
